Habitat Inventory and Assessment of Juanita Creek in 2000

City of Kirkland

King County Department of Natural Resources and Parks
Water and Land Resources Division

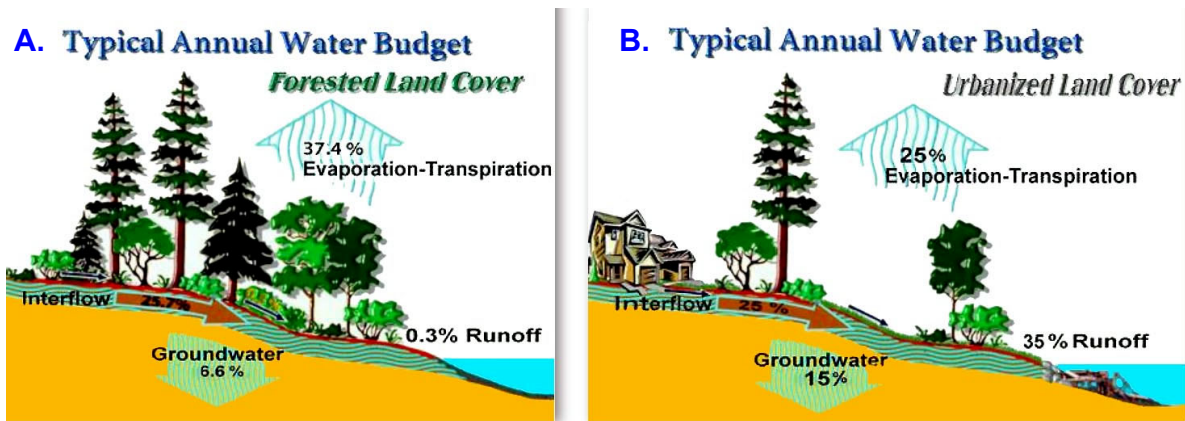
Figure 1. Typical annual water budget in watersheds with (A) forested land cover and (B) urbanized land-cover.

Modifications to natural land cover and the drainage network that result from urbanization change the hydrologic regime of the basin land-cover (Horner and May 1999) (Figure 1)). Under natural land-cover conditions in the PNW most stormwater infiltrates, and stormwater runoff is

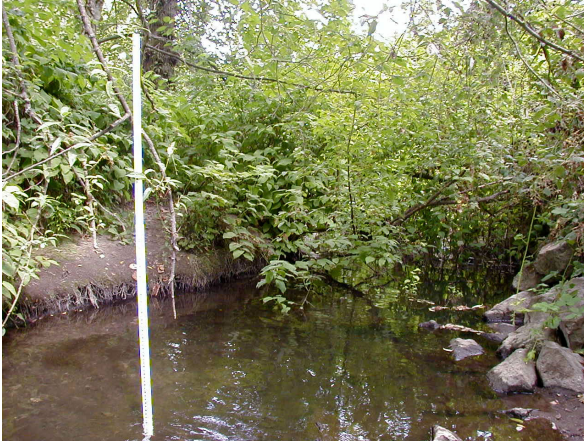
Segment 1. Bank armoring and trampling was typical in this segment. Blackberry vines (*Rubus laciniatus*) were also abundant.

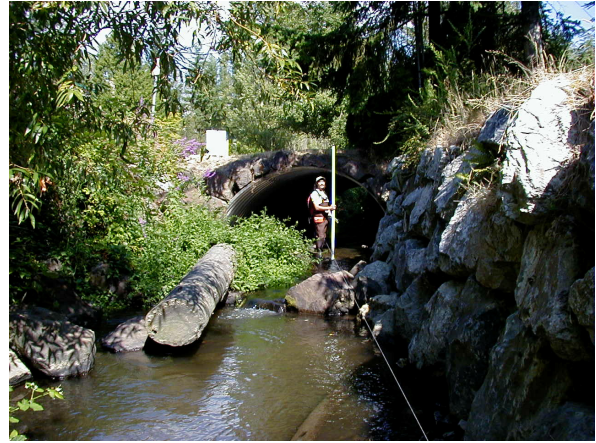
Segment 1. Culvert at NE 120th Street. Armoring typical of this segment.

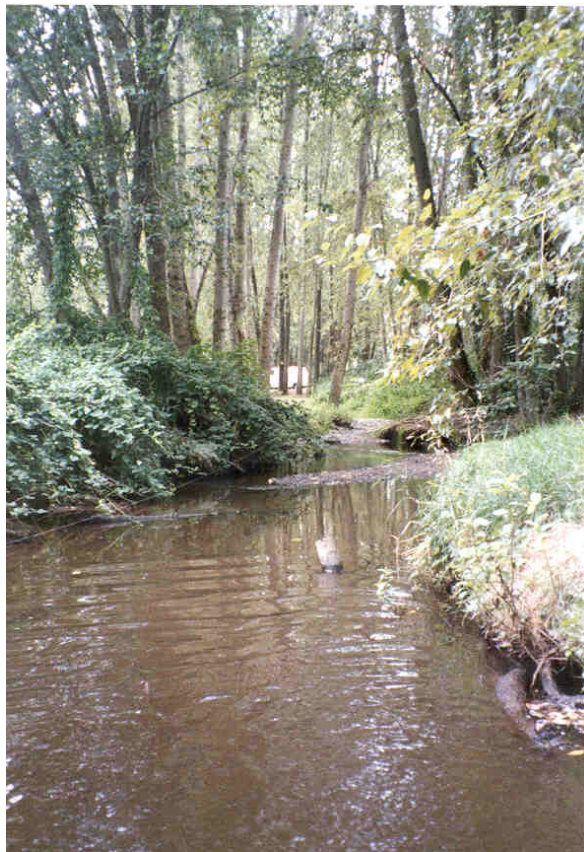
Segment 2. This photo is taken looking downstream toward NE 124th Street. Note the large amount of sediment aggradation, and invasives in the riparian zone.

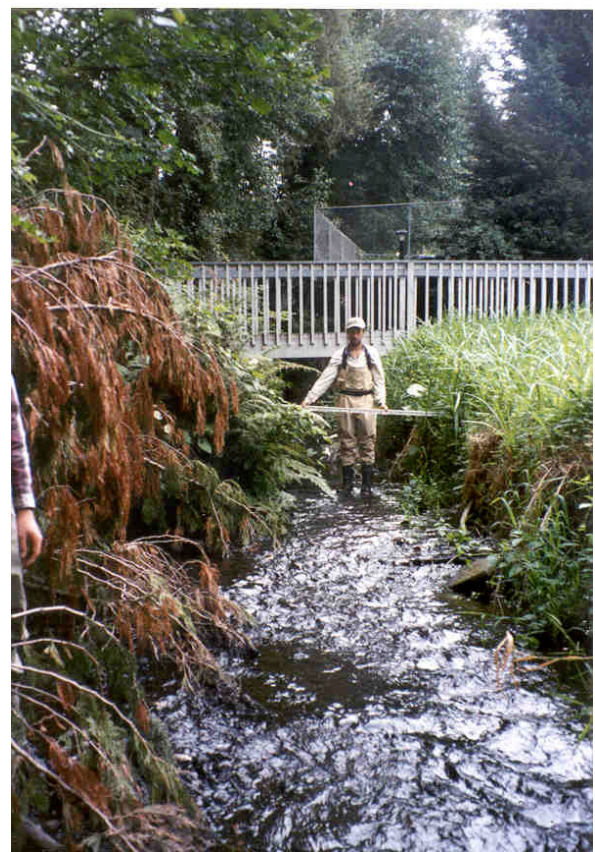
Segment 2. Residential encroachment on the riparian zone and channelized stream reaches were typical in this segment. A large piece of wood on the right bank was viewed as an eyesore and a hazard by adjacent property owners.

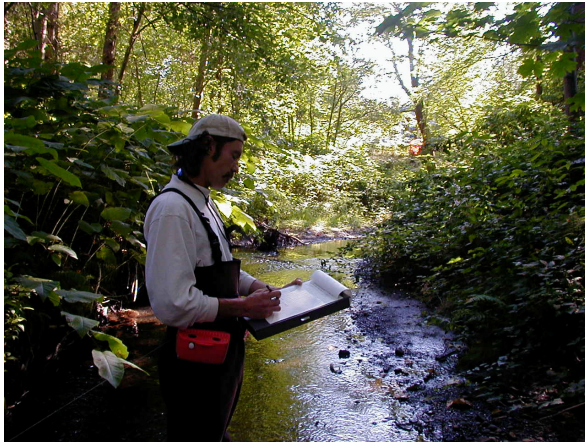
Segment 3. The stream margins are dominated by invasives at this site, blackberry vines on the right, and Japanese knotweed (*Polygonum cuspidatum*) on the left.

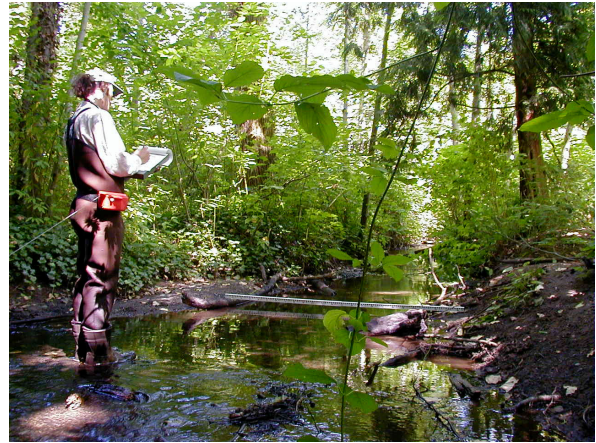
Segment 4. Little LWD, and compacted stream bank characterize this reach.

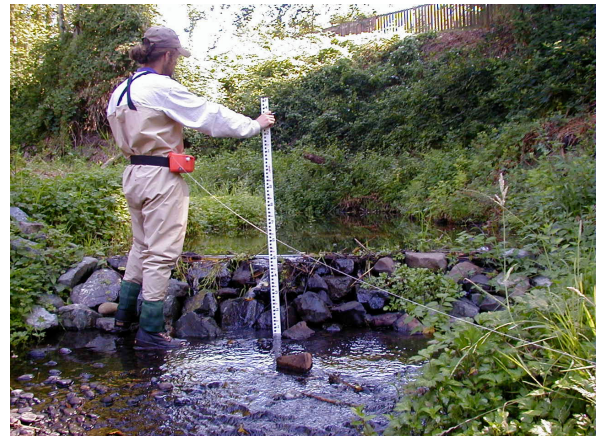
Segment 5. Residential encroachment on the riparian buffer can lead to increased access and alteration to the channel.

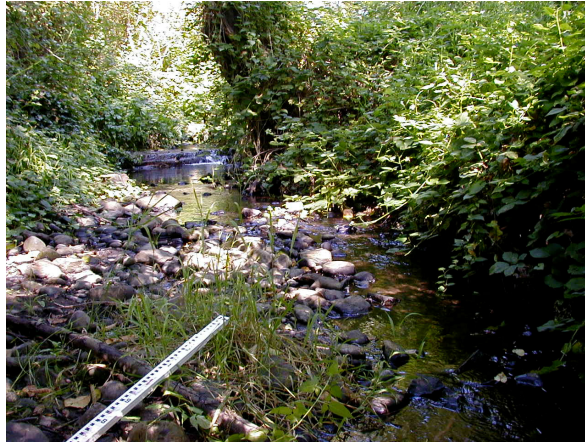
Segment 5. Riparian buffer appears to be well vegetated in this reach, and contains a considerable blackberry vine component.
